DEPARTMENT OF TRANSPORTATION**DIVISION OF ENGINEERING SERVICES**

Contract #: 04-0120F4Cty: SF/ALA Rte: 80 PM: 13.2/13.9File #: 1.28**WELDING INSPECTION REPORT****Resident Engineer:**Pursell, Gary**Address:** 333 Burma Road**City:** Oakland, CA 94607**Report No:** WIR-012273**Date Inspected:** 24-Feb-2010**Project Name:** SAS Superstructure**OSM Arrival Time:** 800**Prime Contractor:** American Bridge/Fluor Enterprises, a JV**OSM Departure Time:** 1630**Contractor:** American Bridge/Fluor Enterprises, a JV**Location:** Job Site**CWI Name:** Tom Pasqualone**CWI Present:** Yes No**Inspected CWI report:** Yes No N/A**Rod Oven in Use:** Yes No N/A**Electrode to specification:** Yes No N/A**Weld Procedures Followed:** Yes No N/A**Qualified Welders:** Yes No N/A**Verified Joint Fit-up:** Yes No N/A**Approved Drawings:** Yes No N/A**Approved WPS:** Yes No N/A**Delayed / Cancelled:** Yes No N/A**Bridge No:** 34-0006**Component:** Orthotropic Box Girders (OBG)**Summary of Items Observed:**

1) OBG field splice fit-up

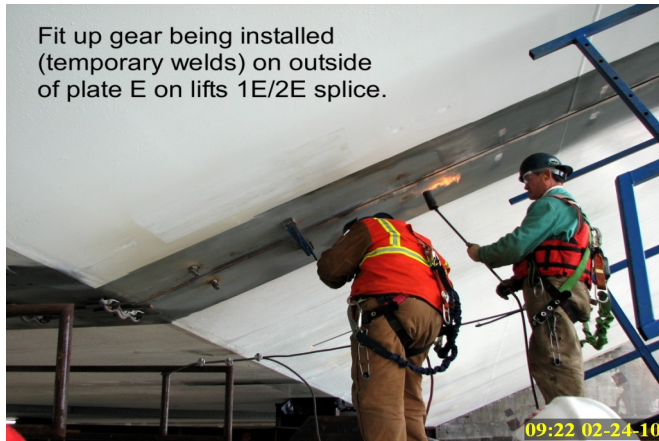
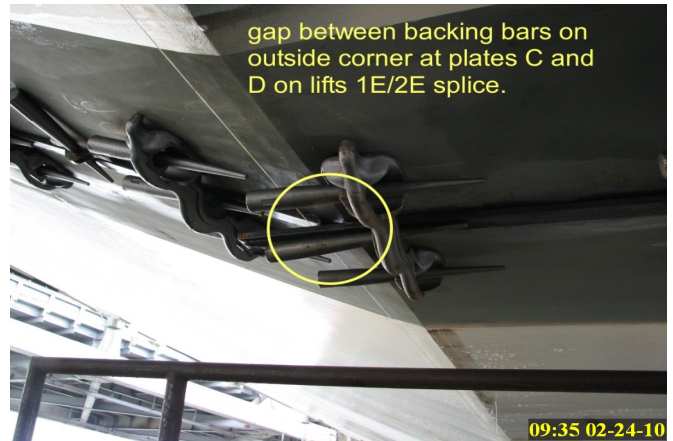
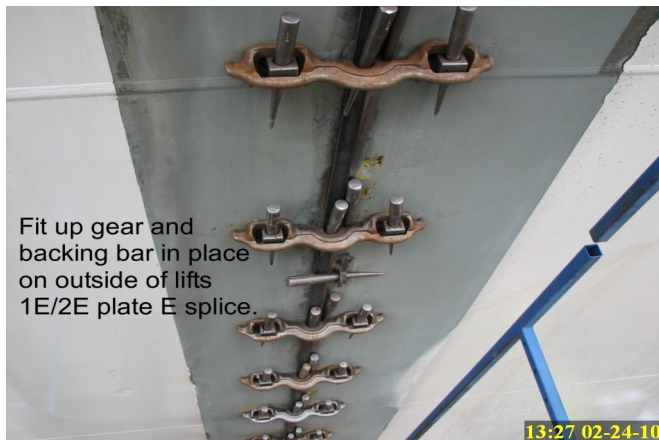
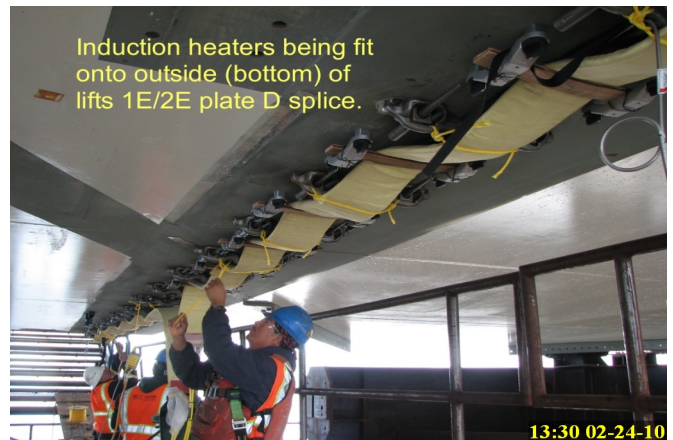
1) The QAI observed the installation and fillet welding of temporary fit up aids (fit up gear) on side plate E at OBG lifts 1E/2E field splice. The temporary fillet welding was performed by ABF welder Mitch Sittinger, ID 0315. The QAI observed the Quality Control (QC) Inspector Tom Pasqualone monitoring the welding of the fit up aids at this location. The QAI noted that shielded metal arc welding (SMAW) with 1/8" E7018 electrodes are being used and the QAI was informed that Welding Procedure Specification (WPS) ABF-WPS-D15-F1200A-1 is being used for the temporary fillet welds. The QAI made random observations of welding parameters and preheat temperature which were measured at 130 DC amps and a minimum temperature of 150°F. The QAI noted that the workmanship appeared to be generally conforming to the contract requirements. See the attached photos. The QAI noted that the outside (bottom) of side plate E has 17 pairs of attachments for the fit up gear. The QAI was informed that the backing bar will be fit in, and trimmed at the corner where plate D backing bar intersects. The QAI was informed that the backing bars will not be spliced together, as they will be removed from the weld. The QAI observed that there is a gap between the backing bars at this location and at the side plate C to plate D intersection as well. See the attached photo.

The QAI also made observations of the backing bars' fit-up on the side plates C and E and noted that there are gaps

visible, the largest gap observed was measured at 3mm between the backing bar and Lift 2E on the side plate C. The QAI was informed that the fit up of the joints and backing bars will be verified and/or modified prior to the start of production welding. The QAI also observed ABF personnel installing induction heating pads under the field splice of bottom plate D. The QAI noted that the heaters are not in intimate contact with the base metals due to the temporary attachments used for fitting up the splice. The QAI was informed that these heaters will not be the primary heaters and will only be used to help stabilize the preheat temperature. See the attached photo. This work was in progress at the end of the QAIs shift.
